Contract #: 04-0120F4Cty: SF/ALA Rte: 80 PM: 13.2/13.9File #: 69.28**WELDING INSPECTION REPORT****Resident Engineer:**Pursell, Gary**Address:** 333 Burma Road**City:** Oakland, CA 94607**Report No:** WIR-000648**Date Inspected:** 17-Oct-2007**Project Name:** SAS Superstructure**OSM Arrival Time:** 600**Prime Contractor:** American Bridge/Fluor Enterprises, a JV**OSM Departure Time:** 1530**Contractor:** Zhenhua Port Machinery Company, Ltd (ZPMC), Changxing Island **Location:** Shanghai, China**CWI Name:** Sha Zhi, Xu Liang Zhang**CWI Present:** Yes No**Inspected CWI report:** Yes No N/A**Rod Oven in Use:** Yes No N/A**Electrode to specification:** Yes No N/A**Weld Procedures Followed:** Yes No N/A**Qualified Welders:** Yes No N/A**Verified Joint Fit-up:** Yes No N/A**Approved Drawings:** Yes No N/A**Approved WPS:** Yes No N/A**Delayed / Cancelled:** Yes No N/A**Bridge No:** 34-0006**Component:** Caltrans mock up**Summary of Items Observed:**

Caltrans Quality Assurance (QA) Inspector, Dan Hernandez was present to observe the fitup, welding and related activities associated with the fabricating of Caltrans Mock-up 89.00, for the San Francisco Oakland Bay Self Anchored Suspension Bri

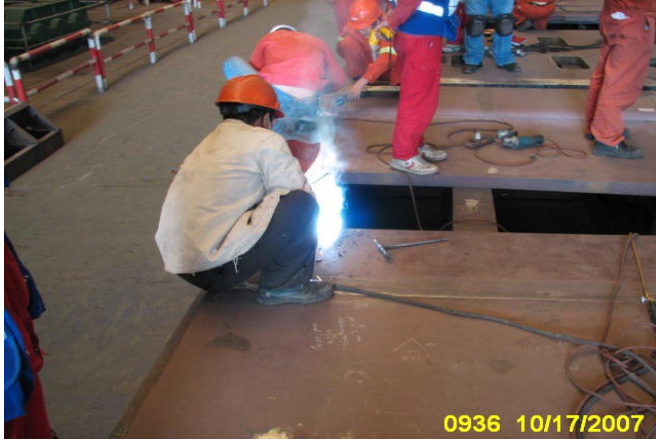
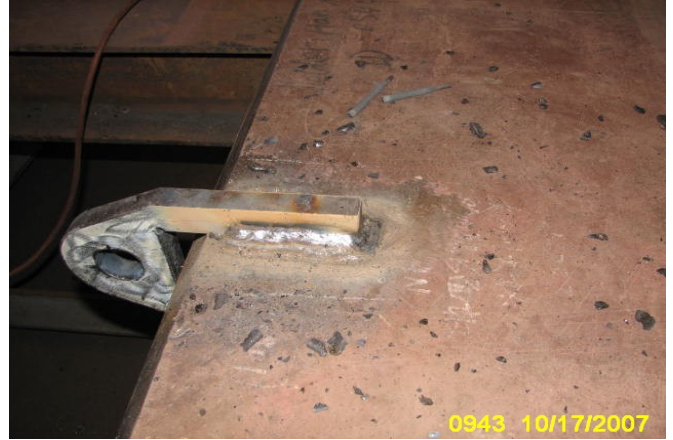
Item	Description	WBS	Dwg No.	Status
1	Mock-Up 89.00, skin plate B			lift brackets completed
	Caltrans QA Inspector observed shielded metal arc welding (SMAW) of fillet welds on temporary lifting brackets to plate mp505. The welder was observed welding in the 2f position using a chipping hammer and wire brushing during interpass weld cleaning. The approved welder has designated welder stamp ID 049804. The welder is using welding procedure specification (WPS) WPS-B-P-2112. Caltrans QA Inspector measured current welding parameters at approximately 171 amps and 150 millimeters per minute (mm/min) travel speed.

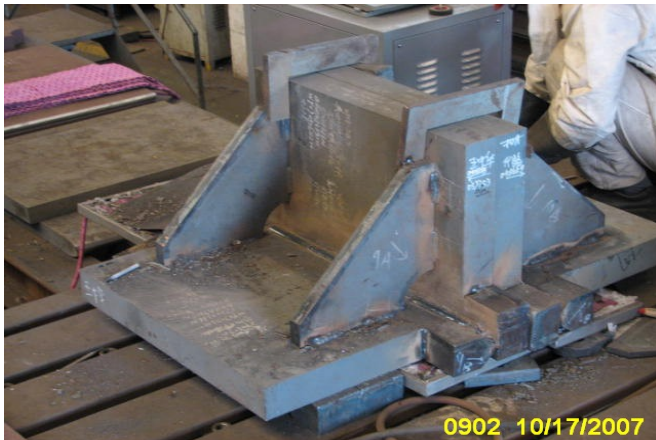
2 89 M Strut Assembly

Caltrans QA Inspector observed SMAW in progress of fill passes on plates P913-1 to SA24-1 weld 9A MUB-MA21. The weld joint is a Complete Joint Penetration (CJP) double bevel butt-joint in the 1G position. The approved welder # 049804 was using approved WPS, WPS-B-T-3211-TC-U5B. Caltrans QA Inspector observed current welding parameters at approximately 252 amps, 25 volts and 170 millimeters per minute (mm/min) travel speed. Preheat and interpass temperatures were verified during welding activities. The preheat temperature prior to the start of welding measures more than 110 Celsius (230 degree Fahrenheit) but less than 232 Celsius (450 degrees Fahrenheit) during maximum interpass temperature verification. SMAW welding consumable is verified and identified as classification E9018 H4R Excalibur 4.8mm diameter. An electrode oven was observed by Caltrans QA Inspector in use during the welding process. ZPMC Quality Control (QC) Certified Welding Inspector (CWI) Mr. Sha Zhi and Bureau Veritas Inspector, Mr Xu Liang Zhang were observed monitoring welding activities at the workstation.

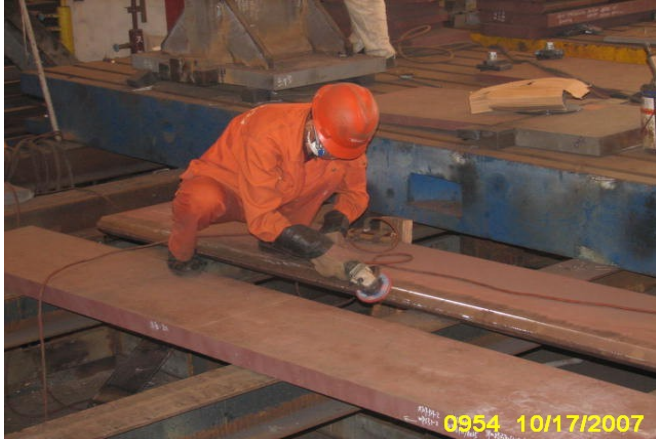
3 89M Stiffener plates

cleaning at weld joint co

Caltrans QA Inspector observed ZPMC cleaning the weld zone of stiffener plate's mp531-1 and mp531-2 with an sanding disk.
